**MEMORANDUM**

TO: Hazardous Waste Enforcement File  
Green America Recycling, LLC  
Hannibal, Ralls County, MO  
EPA ID # MOD054018288

SUBJECT: Site Visit – Green America Recycling, LLC  
10107 Hwy 79  
Hannibal, MO 63401

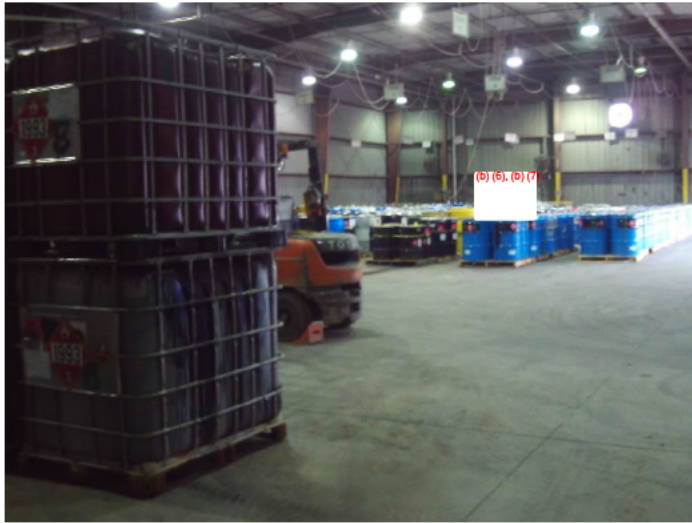
**Photograph: # 1.**  
**Taken By:** Cheyenne Bure  
**Date Taken:** March 11, 2020  
**Program:** Waste Management

**Entity:** Green America Recycling, LLC  
**Permit:** MOD054018288  
**Location:** CSA #4  
**Description:** Looking north in CSA #4. Drums are stored on northern side of building, totes are stored on the southern side of building.

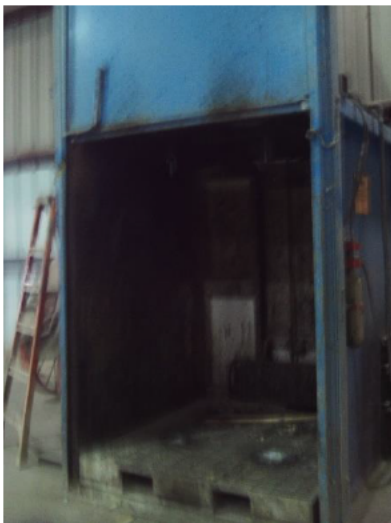
**Photograph: # 3.**  
**Taken By:** Cheyenne Bure  
**Date Taken:** March 11, 2020  
**Program:** Waste Management

GAR uses a 'drum piercing' machine to de-pressurize incoming drums (Photos #3 - 5). A maximum of four drums may be placed on a pallet at one time and are loaded into the machine using a fork lift.

**Entity:** Green America Recycling, LLC  
**Permit:** MOD054018288  
**Location:** CSA #4  
**Description:** Note 4 spikes for puncturing situated at the top of the unit.

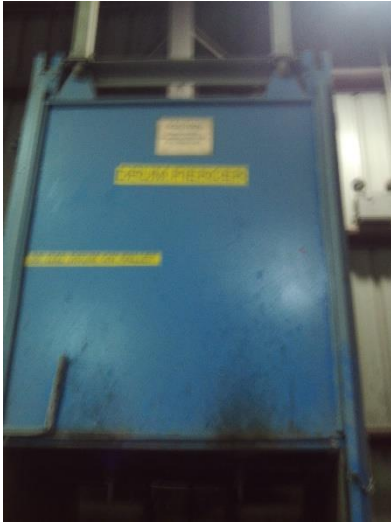
**Photograph:** # 4.  
**Taken By:** Nicole Eby  
**Date Taken:** March 11, 2020  
**Program:** Waste Management

This puncturing process began after an incident when an employee was injured while opening a pressurized drum. The machine was made by GAR and does not have the means to capture emissions that escape from the drums during the piercing process. Additionally, the building in which CSA #4 is located, is not under negative pressure or have other means to capture fugitive emissions from this process.

**Entity:** Green America Recycling, LLC  
**Permit:** MOD054018288  
**Location:** CSA #4  
**Description:** Door to the drum puncturing machine, raised and partial view of puncturing spikes. Once drums are loaded into the machine a handle is used to lower the door and the spikes. The spikes puncture the drums to depressurize them while the door is closed to capture any projectiles while puncturing.

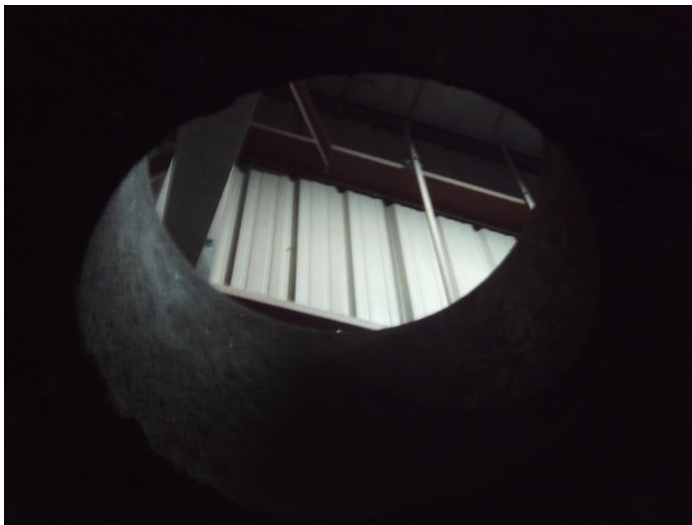
**Photograph:** # 5.  
**Taken By:** Nicole Eby  
**Date Taken:** March 11, 2020  
**Program:** Waste Management

**Entity:** Green America Recycling, LLC  
**Permit:** MOD054018288  
**Location:** CSA #4  
**Description:** Inside the drum puncturing machine looking upwards. Facility says an 'explosion vent' is normally covering the hole. The vent is used to help prevent pressurized projectiles from escaping the unit but does not appear to capture emissions even when in place.

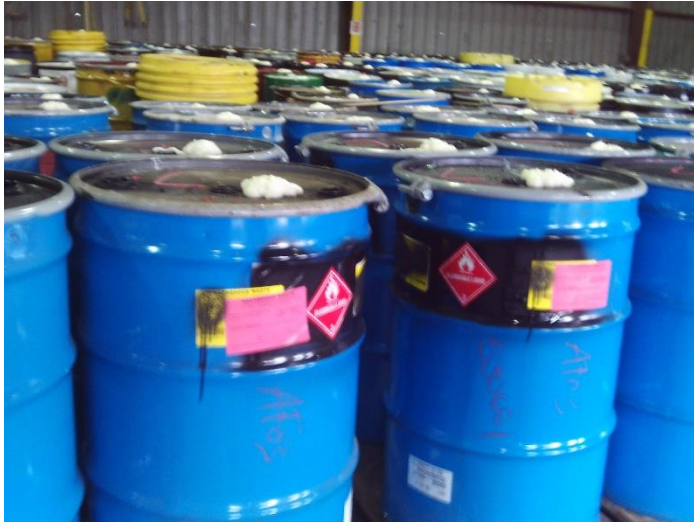
**Photograph: # 6.**  
**Taken By:** Nicole Eby  
**Date Taken:** March 11, 2020  
**Program:** Waste Management

The expanding foam that is used to close the puncture holes is not always compatible with the hazardous waste in the drums. When the foam is in contact with some waste it may dissolve, resulting in open containers. Two violations were cited in EPA's May 14, 2019 inspection report due to the incompatibility: Special Permit Condition I.E.1, Compatibility of Waste with Containers [40 C.F.R. 264.172] and Special Permit Condition I.F, Management of Containers [40 C.F.R. 264.173].

**Entity:** Green America Recycling, LLC  
**Permit:** MOD054018288  
**Location:** CSA #4  
**Description:** 55 gallon drums in storage, already punctured with foam sealing holes.

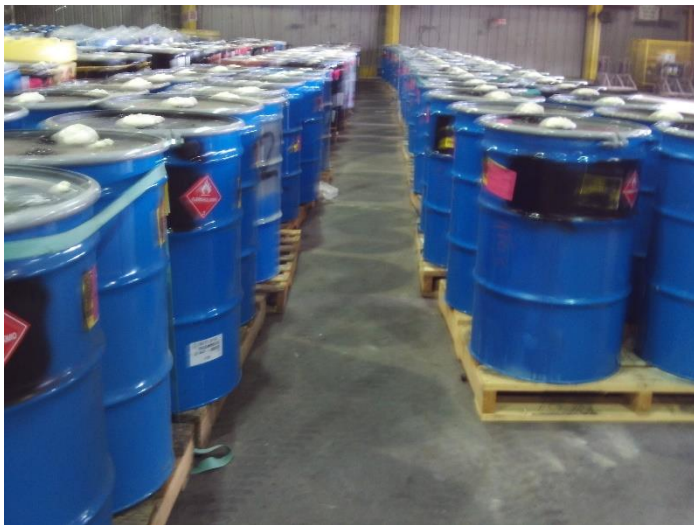
**Photograph: # 7.**  
**Taken By:** Nicole Eby  
**Date Taken:** March 11, 2020  
**Program:** Waste Management

**Entity:** Green America Recycling, LLC  
**Permit:** MOD054018288  
**Location:** CSA #4  
**Description:** 55 gallon drums in storage, already punctured with foam sealing holes.

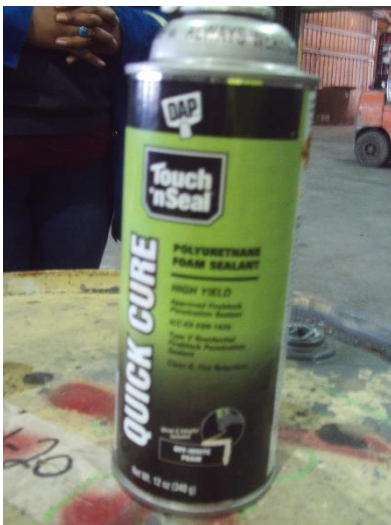
**Photograph: # 8.**  
**Taken By:** Nicole Eby  
**Date Taken:** March 11, 2020  
**Program:** Waste Management

(b) (6), (b) (7)(C), explained the drum receiving process to us. Hazardous waste drums are received from generators of hazardous waste to be used as fuel for the kiln at GAR. The drums are taken to CSA #4 for staging before being used in the kiln. The drums are punctured to relieve pressure and occasionally sampled to confirm the content of the drum. The puncture hole is then closed using an expanding foam (Photo #8). The drums stored in CSA #4 are generally used in the kiln within 48 hours of receiving.

**Entity:** Green America Recycling, LLC  
**Permit:** MOD054018288  
**Location:** CSA #4  
**Description:** Expanding foam used to close drums.

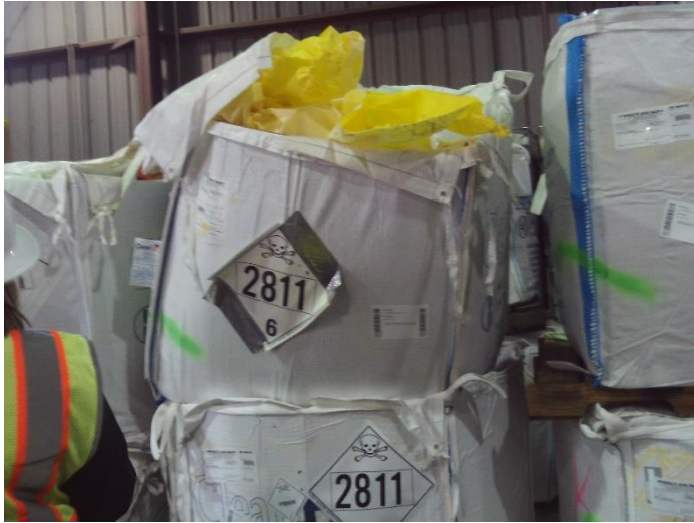
**Photograph: # 9.**  
**Taken By:** Nicole Eby  
**Date Taken:** March 11, 2020  
**Program:** Waste Management

**Entity:** Green America Recycling, LLC  
**Permit:** MOD054018288  
**Location:** CSA #4  
**Description:** Cubic yard containers for dry hazardous waste storage. Not all containers were properly closed. Used yellow PPE is shown here coming out of container.

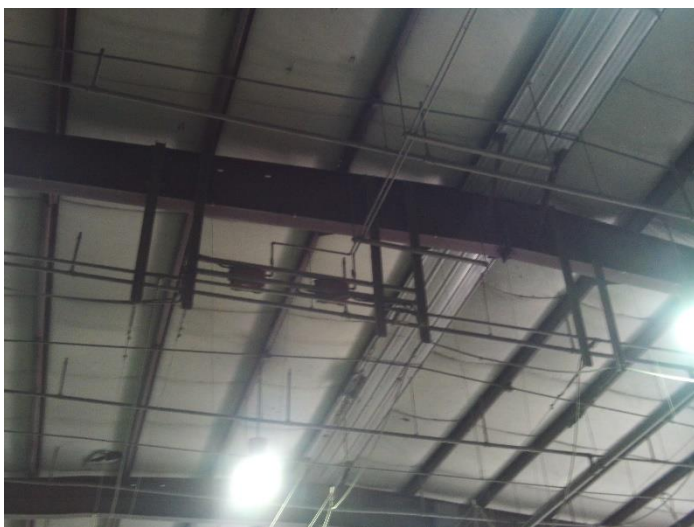
**Photograph: # 14.**  
**Taken By:** Nicole Eby  
**Date Taken:** March 11, 2020  
**Program:** Waste Management

**Entity:** Green America Recycling, LLC  
**Permit:** MOD054018288  
**Location:** CSA #4  
**Description:** Fire suppression pipes are suspended from the ceiling.

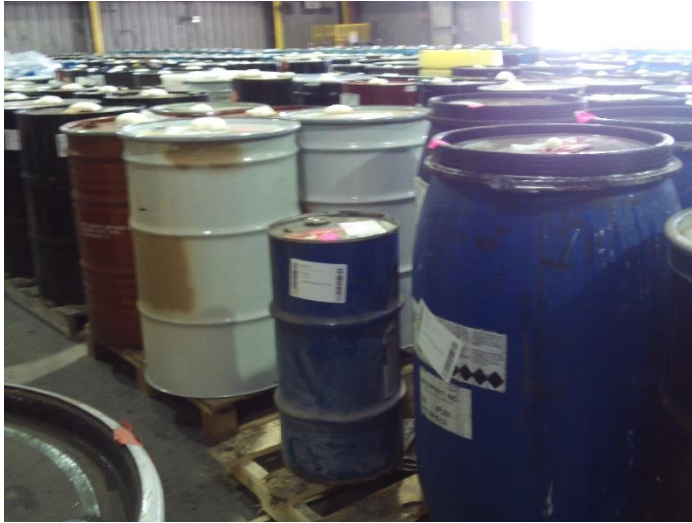
**Photograph: # 18.**  
**Taken By:** Nicole Eby  
**Date Taken:** March 11, 2020  
**Program:** Waste Management

**Entity:** Green America Recycling, LLC  
**Permit:** MOD054018288  
**Location:** CSA #4  
**Description:** Hazardous waste drums in storage. Sizes of the containers vary from 5 gallons to 55 gallon overpacks.

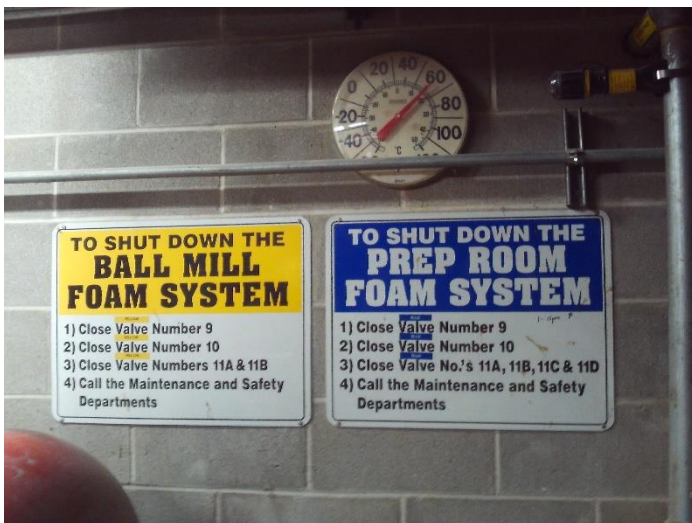
**Photograph: # 19.**  
**Taken By:** Nicole Eby  
**Date Taken:** March 11, 2020  
**Program:** Waste Management

**Entity:** Green America Recycling, LLC  
**Permit:** MOD054018288  
**Location:** Fire house #1  
**Description:** Temperature reading inside Fire house #1, piping and signs describing how to shut down the ball mill and prep room systems.

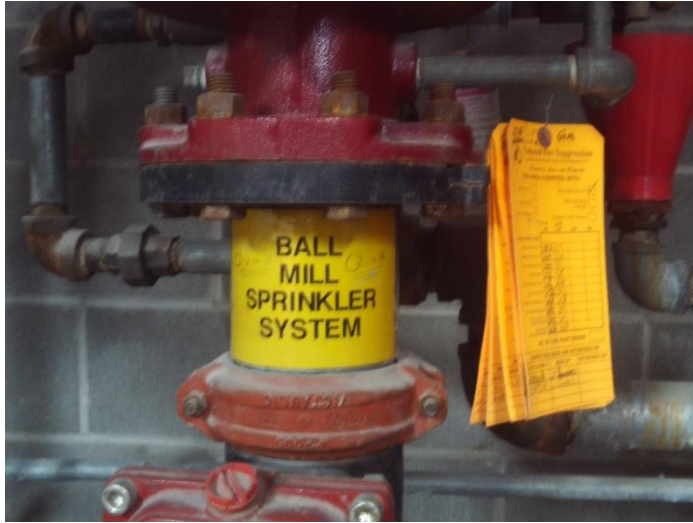
**Photograph:** # 24.  
**Taken By:** Nicole Eby  
**Date Taken:** March 11, 2020  
**Program:** Waste Management

**Entity:** Green America Recycling, LLC  
**Permit:** MOD054018288  
**Location:** Fire house #1  
**Valves and inspection tags for the Ball Mill Sprinkler System in Fire House 1.**

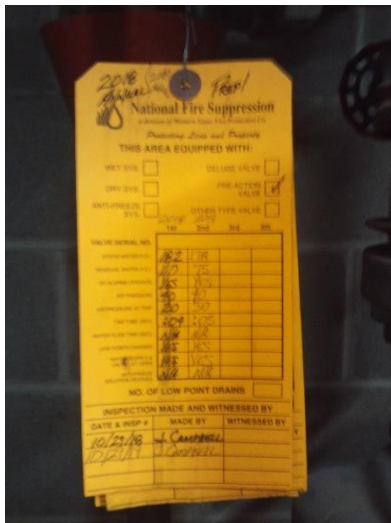
**Photograph:** # 25.  
**Taken By:** Nicole Eby  
**Date Taken:** March 11, 2020  
**Program:** Waste Management

**Entity:** Green America Recycling, LLC  
**Permit:** MOD054018288  
**Location:** Fire house #1  
**Description:** Close up of inspection tags in Photograph #24
